Multiple Borehole Remediation Loire Valley France.

Cirrus in were contacted by the operator of a water wellfield in the Loire Valley. All three were of the radial or collector well type, St Maur 1, St Maur 2 and La Chesnaie.

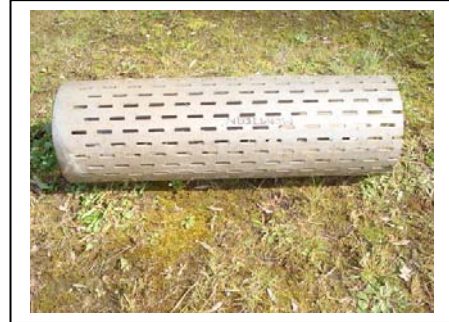
Slotted casing used in radial construction.

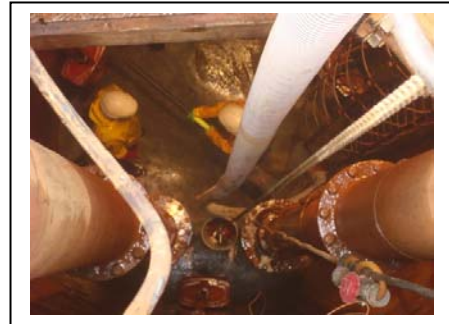
De Sanding operations

During routine “de-sanding” all radial service valves are closed, the main chamber drained and a high volume service pump installed. Once this pump is in place a single radial is opened and manual de-sanding and jetting can be performed.

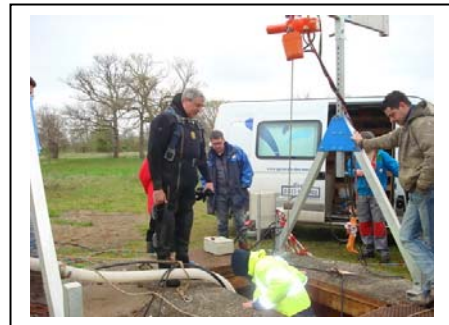
Diver preparing to descend

To undertake AirBurst in an efficient manner and minimize downtime a modified approach was used which negated the need to drain down the main chamber. The main service valves were closed as before and a pump installed. The service valve for the radial to be treated was opened. A diver was then used to insert and push the AirBurst tooling along the radial. Once the diver had surfaced the service pump was activated and AirBurst operations commenced. The treatment was repeated in the radial as decided by the AirBurst operator. For each well the AirBurst process was used on day 1 and on day 2 the additional material produced from AirBurst removed by de-sanding as above.

For diving operations a number of safety measures were implemented from lockout devices to backup diver and safety lift mechanisms. Full communications were maintained with the diver at all times during operations.

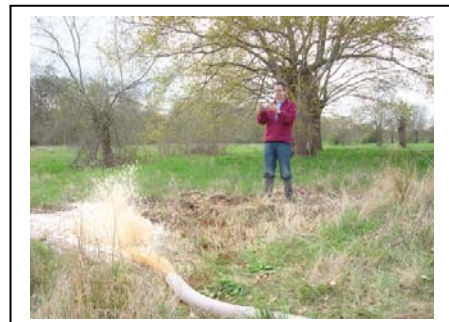
Material produced during AirBurst

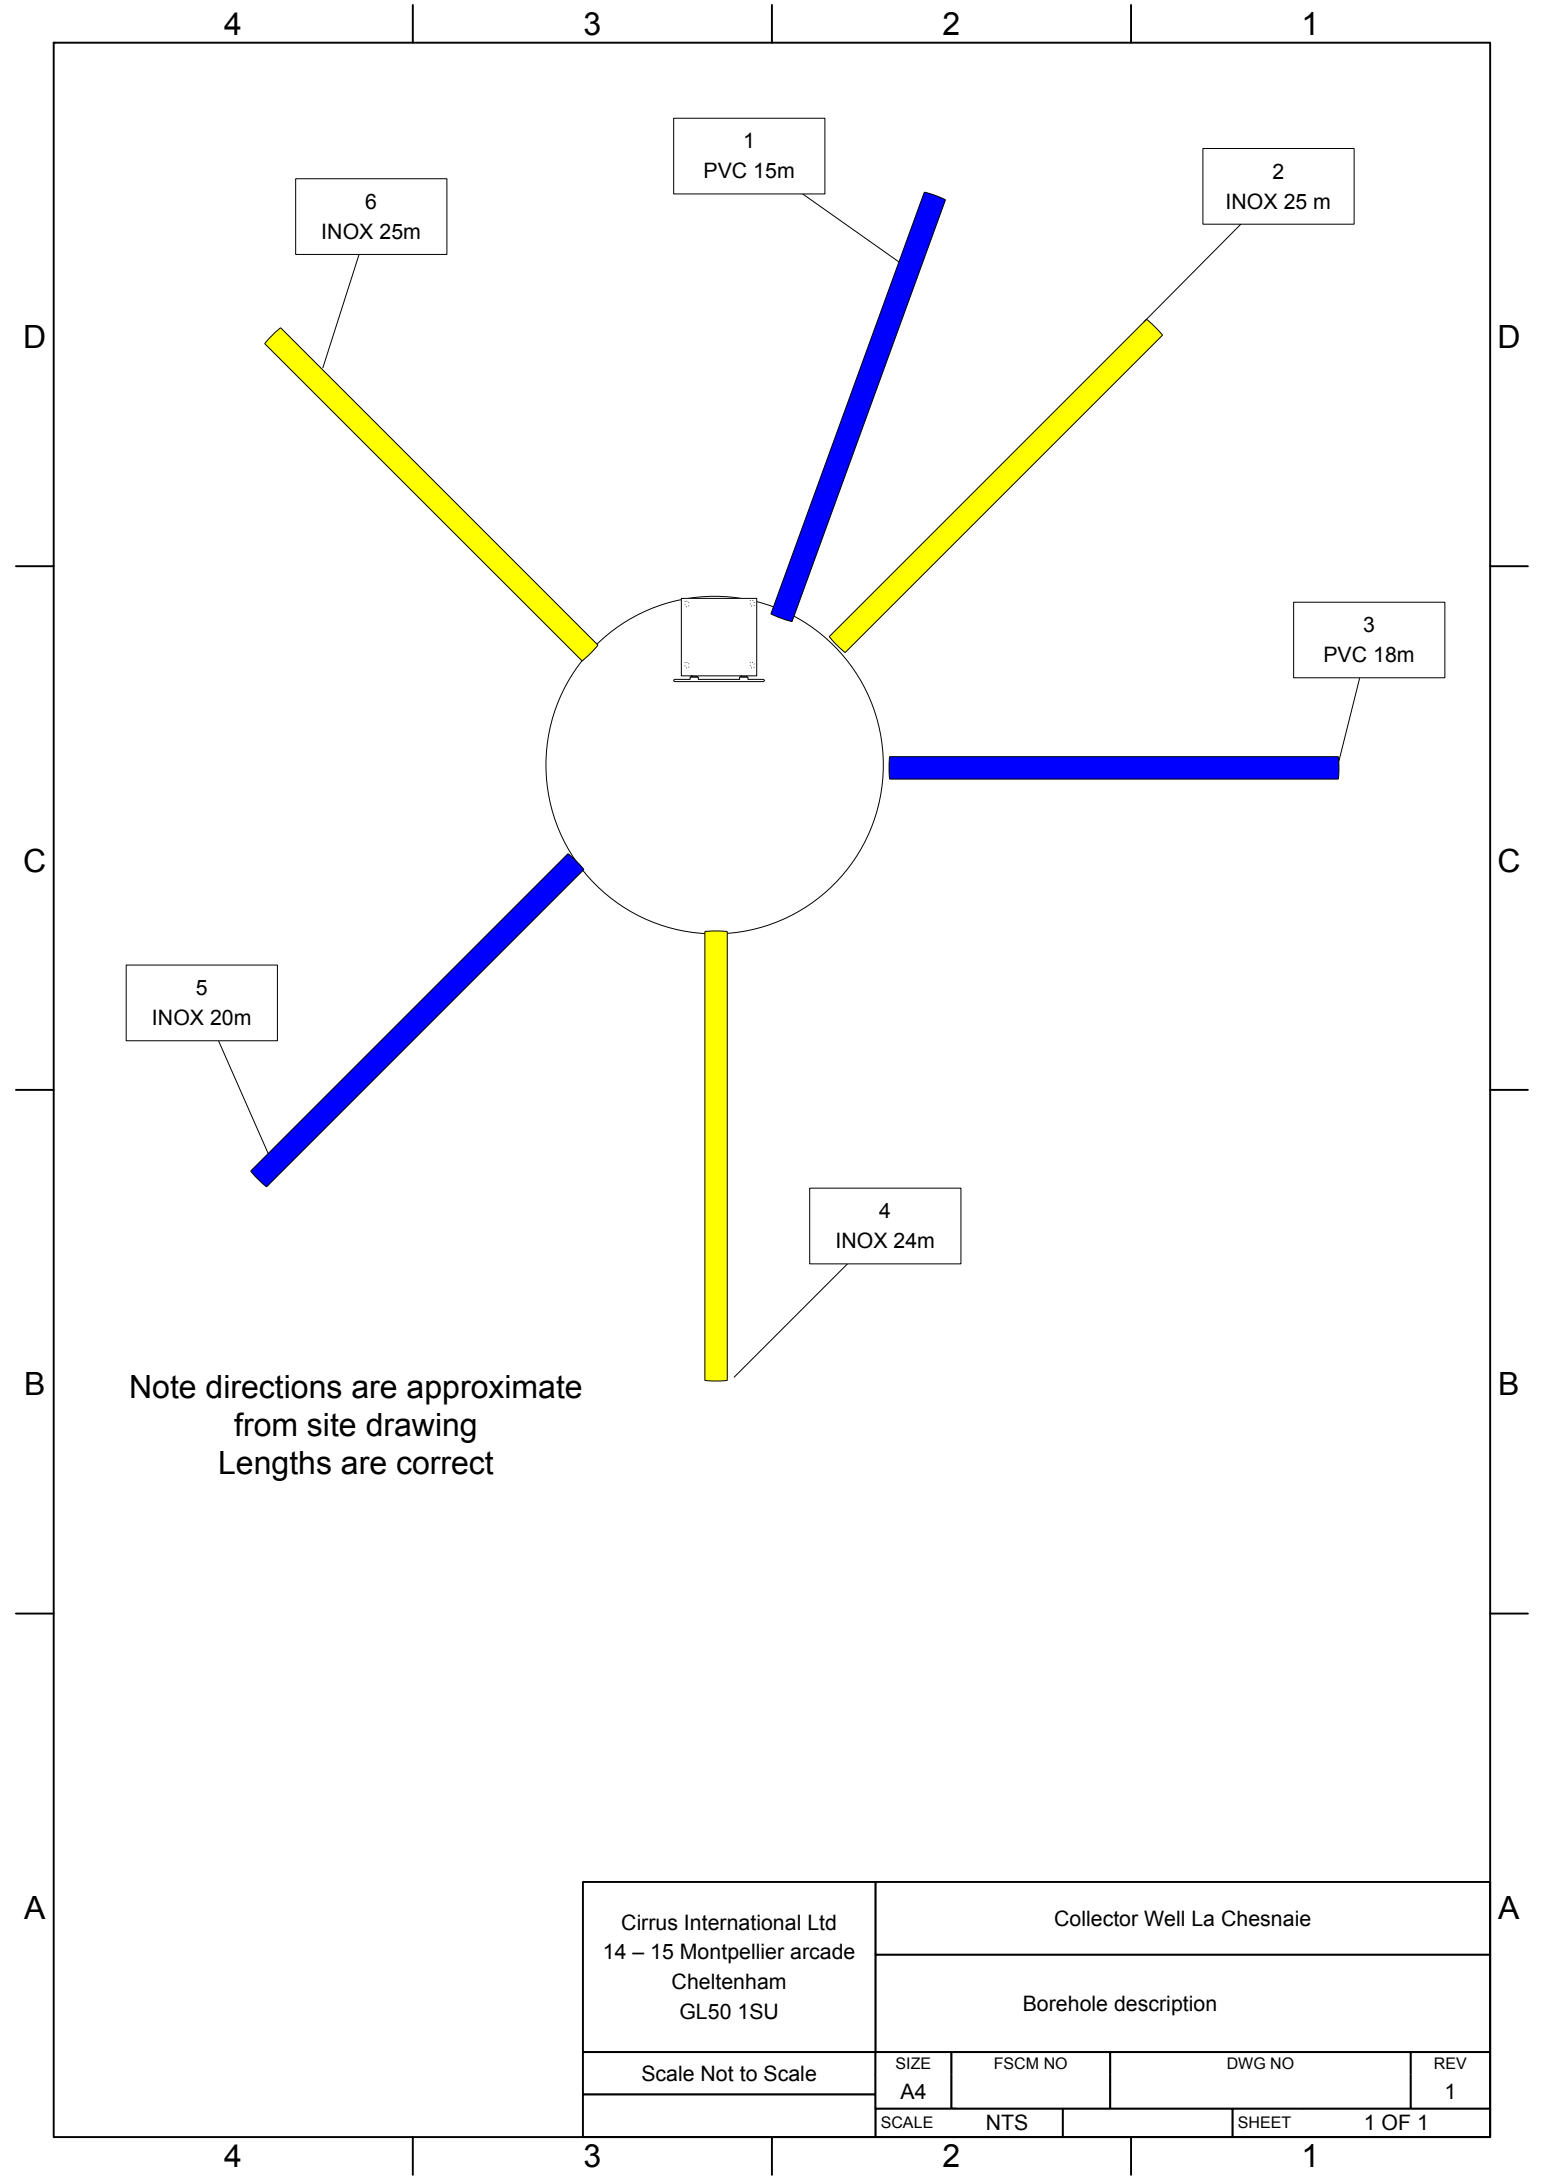
Cirrus International Ltd 14 – 15 Montpellier arcade Cheltenham GL50 1SU	Collector Well La Chesnaie			
	Borehole description			
Scale Not to Scale	SIZE A4	FSCM NO	DWG NO	REV 1
	SCALE NTS	SHEET 1 OF 1

Note directions are approximate
from site drawing
Lengths are correct

Air burst cette année car le puits a un très mauvais rabattement depuis 3 ans
(attention 3 drains en PVC, nous avons fait une inspection caméra avant)

In all three cases good results were obtained. St Maur 1 had been brought from 70m³/m a few years previously. La Chesnaie presented a particular problem in that some of the drains were PVC so had to be treated with reduced energy, however good results were still obtained. The 60 m³/m figure for La Chesnaie was after various other clearance and cleaning methods were used.
